In this bulletin...

MARS 202524

MARS 202525

MARS 202526

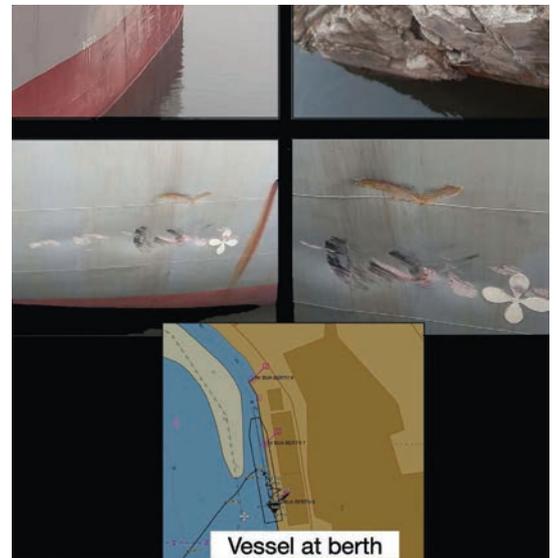
On the approach to the berth, the vessel was making 4.8 knots before corrective actions were initiated. Despite multiple engine manoeuvres and the eventual deployment of the port anchor, the vessel contacted the pier at a speed of 0.9 knots.

Damage to the vessel was concentrated at the starboard bow and the aft starboard quarter. The company investigation found, among other things, that a combination of environmental, operational, and systemic factors contributed to the incident. Strong currents and shallow waters were significant contributors, impeding the vessel's manoeuvrability and amplifying the challenges posed by the angular design of the pier. These natural challenges were compounded by local regulations, which restricted tug operations to push-assist only, eliminating their ability to provide 'pull' support.

Communication gaps between the vessel's bridge team, the pilot, and the tug operators were also identified as a critical factor. Additionally, the delayed deployment of the port anchor limited its capacity to counteract the vessel's swing to starboard during the final moments of the approach.

- The importance of comprehensive pre-berthing planning and preparation should not be underestimated.
- Open and continuous communication between the Master, pilot, and tug operators is essential for addressing the dynamic challenges associated with berthing operations.
- Regular drills focusing on emergency responses, such as timely anchor deployment and adaptive manoeuvring, are vital to ensuring that crews are prepared for similar scenarios.

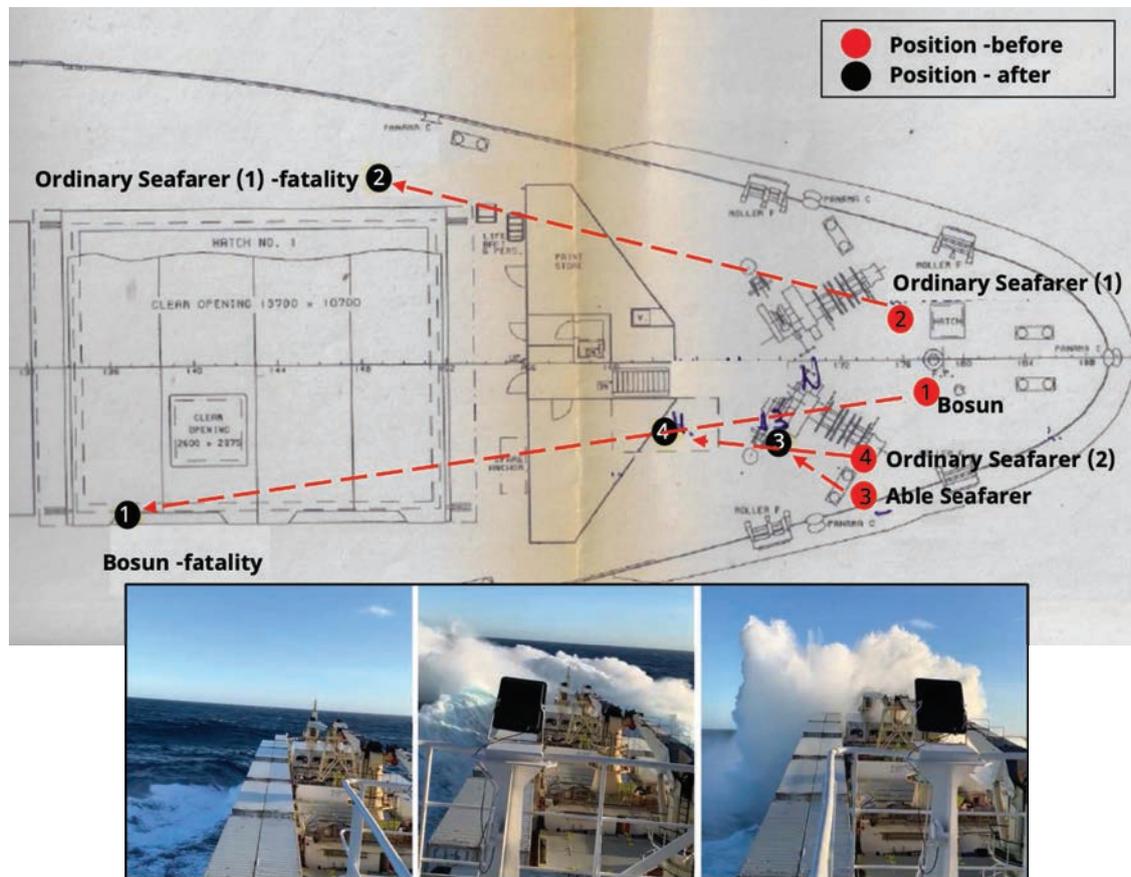
View of seas encountered (one hour after accident)

The vessel encountered increased swell activity, causing it to slam. This woke the Master, and he instructed the officer of the watch (OOV) to reduce speed and alter course to minimise the slamming effects. By midday, the swell had increased. Wave heights were now more than three metres.

After lunch, the chief officer informed the OOV that he was going on deck for a safety check. At around the same time, the bosun and some deck crew, having slept through the morning to recuperate, made their way forward to finish the job of securing the forward mooring station. The vessel was struck by a series of large waves, breaching the forecabin and washing the crew off their feet.

Measures were taken to mitigate the slamming, but at no point was the company's heavy weather checklist used, nor was access to the open deck restricted.
