## In this bulletin...

### **MARS 202605**

### **MARS 202606**

### **MARS 202607**

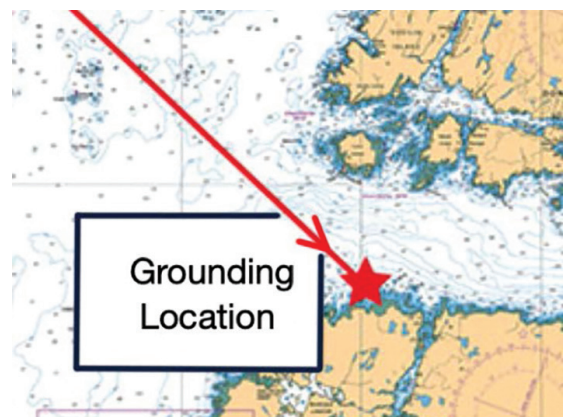
A tug was pushing an oil barge in ballast, so that the two units were operating as an articulated tug and barge (ATB). The OOW took over the watch at 23:00. The vessels were in confined coastal waters with little or no other vessel traffic, light winds and some rain. The OOW was alone in the wheelhouse acting as navigator and lookout. At 00:20 the OOW made a planned course alteration to port. Some 30 minutes later, a further planned course alteration was missed because the OOW had fallen asleep in the bridge chair.

A few minutes after 01:00, the ATB struck a charted reef. The impact woke the OOW. He immediately reversed both engines and placed the rudders hard to port. The Master, awoken by the impact, went to the wheelhouse and took over the watch. The tug’s starboard engine was disabled, so the Master attempted to reverse off the reef with the port engine while moving the rudder hard over, port to starboard. The ATB pivoted but remained aground.

The investigation found, among other things, that the OOW suffered from several fatigue-inducing factors at the time of the grounding, including sleep disruption both acute and chronic, circadian rhythm disruptions, and individual factors (ie his inability to nap during 'off' hours). In other words, he was fatigued.

- 'Sleep hygiene' is a critical element of safety in the transportation industry, yet one that is mostly self-managed. Take it seriously.
- Sitting while navigating is one step towards further relaxation. Standing and moving (between navigation instruments?) means you are unlikely to experience a micro-sleep and may help your situational awareness.

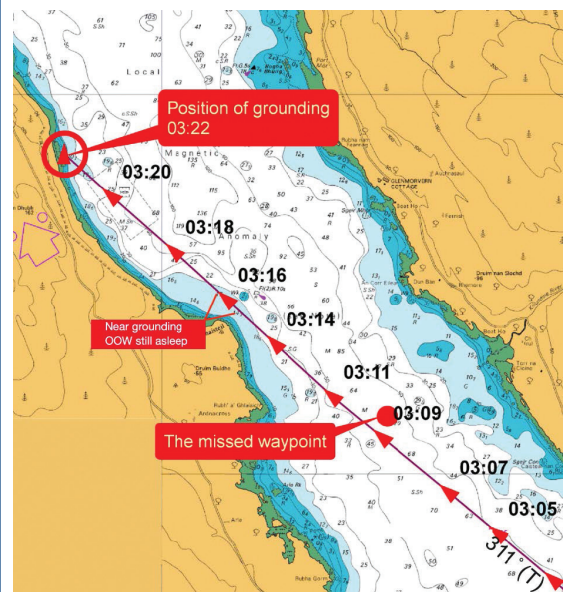
At 02:56, the vessel had reached a course alteration waypoint, and the OOW adjusted the vessel's course. He then went out to the starboard bridge wing to get some fresh air. When he returned inside, he secured the starboard bridge door in the fully open position and sat in the port bridge chair. Shortly afterwards, he fell asleep. The vessel passed the next planned waypoint and maintained its course for just over 2.5 miles, at about 10.5 knots, until the OOW woke up.

Sensing danger, the OOW immediately moved the engine control to neutral, and then full astern, but the vessel grounded nonetheless at 03:22. The Master was woken by the resulting noise and vibration, came to the bridge and sounded the alarm.

Later that day the crew carried out a temporary repair to stem the flooding. The vessel was re-floated at 21:20, making way for a port of refuge. After an inspection the vessel was found to have sustained significant bottom plate and frame damage to the forward part of the hull. Following the inspection, the vessel proceeded to another port to be repaired.

- It is likely the BNWAS alarm was not activated.
- Once again, the OOW was alone on the bridge at night; a precursor for possible bad outcomes.
- Once again, sitting in a chair at night is step one in a two-step sequence of falling asleep on watch.

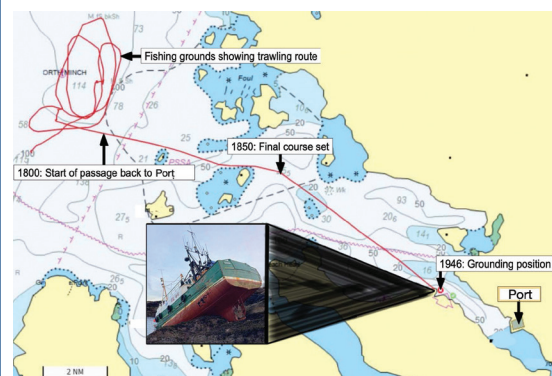
Following this, the skipper had a light lunch and took the afternoon watch. At 17:30, the second tow was hauled. At about 18:00, having recovered the net and catch, the skipper set a course back towards port. At about 19:30, the skipper felt tired, so he opened the wheelhouse windows to let in some fresh air, had a cup of coffee, then sat in the wheelhouse chair. He soon fell asleep.

About 10-12 minutes later, the fishing vessel grounded hard on rocks while making over 7 kts.

The investigation found that the early departure meant that the skipper was unable to obtain enough rest to comply with regulations and operate safely. It is likely that the skipper's decision seemed reasonable at the time because crew were accustomed to feeling tired and the alternative was to miss a day's fishing. However, the decision did not factor in the chronic sleep debt the skipper and crew were already experiencing.

- Some decisions seem to make sense at the time but when considering all the factors, usually after an accident or near miss, the logic often fails.
- Never underestimate the performance inhibiting power of fatigue, which has been characterised as similar to that of alcohol. Reaction time, judgment and risk appreciation, among others, are severely reduced.
- If you need coffee and fresh air to stay awake, these are signs that you need rest. Do not sit down before the end of your watch – or call a relief.
