## In this bulletin...

### MARS 202608

### MARS 202609

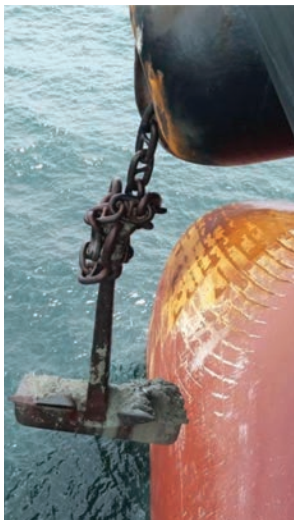
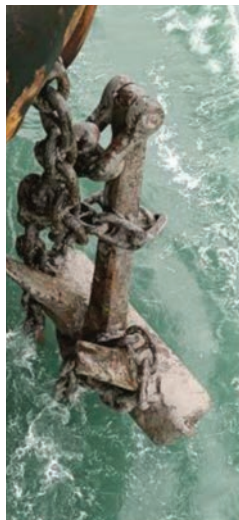
A vessel was picking up anchor after a stay of four days at anchorage, and the anchor chain was found tangled around the shank. A barge was arranged to cut and clear the cable. The incident cost over \$100,000, excluding the off-hire costs.

Similarly, a second vessel had her anchor chain tangled while she was picking up anchor with a pilot on board. The ship needed to be diverted to a port for repairs.

- While dropping anchor, ensure the cable is ranged on the seabed while there is sternway to avoid piling up of the anchor cable.
- Anchor swivels should be checked for free movement during maintenance of the windlass and the anchoring equipment.
- Ensure the anchors are well monitored, especially during the turn of tide.

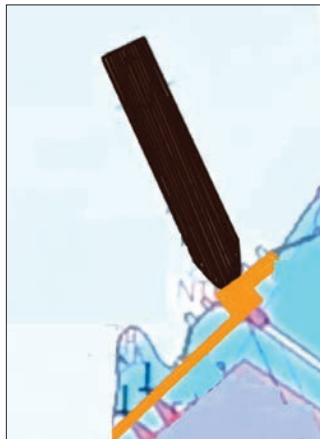
**Position at time of contact**

At various points of the operation the pilot, Master, and chief officer on the bridge, the second mate on deck forward (but not on the bow), and the operator of the forward tug, all noticed that something was not quite right with the approach. However, none of them signalled their unease. Soon the vessel struck the dock, bow on, at over one knot. Although damage to the vessel was relatively minor, resulting in a hole in the bow, damage to the unloading dock was major.

The investigation found, among other things, that the pilot had assumed his PPU 'recognised' the vessel as a frequent caller and that it had therefore automatically applied the antenna offset for this ship. In fact, the offsets were not loaded, which resulted in the displayed ship position on the PPU being more than 200 metres 'astern' of the true position. This error was not caught during the three hours + transit to the dock. By fixating on the PPU image, which was incorrect, the pilot was working on false assumptions.

- Even with perfect weather conditions and in daylight, a well-maintained ship with tug assistance can still unwittingly be driven into a dock if BRM breaks down or is simply non-existent.
- Notwithstanding experienced officers familiar with the port and a pilot, there was no shared mental model of the berth approach among the bridge team.
- Frequent callers and repetitive operations can, paradoxically, cause a lull in standards and lower levels of vigilance.

- An over-reliance on a single data source, in this case the PPU, can lead operators astray sufficiently to cause an accident, even against what should be overriding visual evidence out of the bridge windows that they are running into danger.
- When setting up a PPU, it is good practice to validate the position of the vessel on the PPU as compared to the vessel's ECDIS, and to confirm all offsets if the pilot has installed a complementary portable antenna.
- With no one stationed on the ship's forecandle or on the berth assigned to monitor progress and call out distances the bridge team lacked another important data input source.

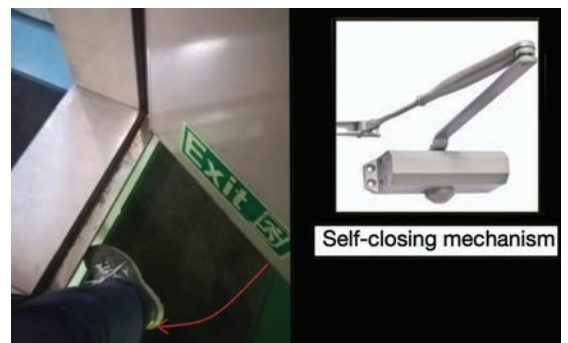
As a crew member was passing through a self-closing fire door into the engine control room, his left foot was caught between the closing door and the door frame. His forward momentum caused him to lurch forward, but his foot was caught and he lost his left shoe. The fire door continued to close and badly pinched his now exposed big toe. He was unfit for work for over a week.

Although the company investigation did not judge the door's closing 'latch speed' to be a factor, they nonetheless found that periodical verification of self-closing devices for all fleet vessels was a worthwhile addition to the vessel's planned maintenance system (PMS).

- In machinery spaces and work environments, well secured protective boots are always recommended.
- Self-closing door mechanisms are adjustable and should be checked from time to time. Door closing speed should be just sufficient to ensure proper closure. Too quick can be a hazard and too slow could mean the door does not have enough energy to catch closed.

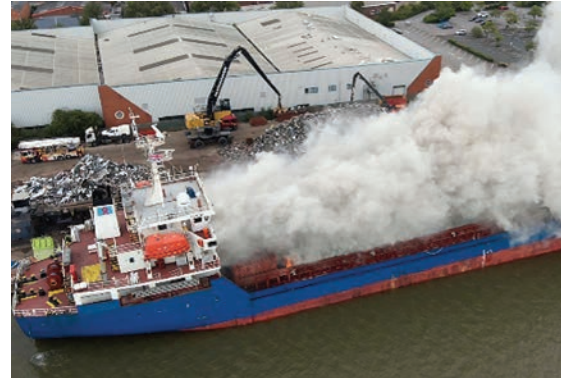
The fire was extinguished the next day. There were no injuries and there was no loss of life. Over several days, crew discharged the contaminated firefighting water from the hold into road tankers for disposal. The scrap cargo was discharged and surveyed to check its composition. The vessel had suffered significant heat damage to structural steelwork in the aft cargo hold.

- The fire was likely caused by an undischarged battery or other ignition source causing a spark during loading, which then ignited combustible material in the scrap cargo.

- The cargo had been classified as group C scrap metal under the IMSBC Code, which did not require the shipper to declare hazard identification and cargo composition. However, the scrap cargo contained hazardous impurities, including batteries, oil drums, and oily residues, which posed a fire risk.

- Appointing a qualified cargo surveying company to assist the vessel's Master before and during loading is a good risk reduction measure.
- Vessels have capsized at berth due to firefighting efforts by shore teams. Close coordination between the Master and fire chief is needed to properly execute the extinguishing effort without further risk to the vessel.
- As seen in MARS reports 202345, 202346 and 202243, while scrap metal may appear innocuous, it is nonetheless a fire risk because of the prevalence of associated combustible materials often present in this cargo.
- Notwithstanding the successful outcome in this case, for a fire in a hold, it may be safer to close the hatches and ventilation and then discharge the fixed CO<sub>2</sub> system than to pour copious amounts of water into the ship, which can negatively affect the vessel's stability.
