In this bulletin...

Rerouting risks

Fire hose cabinet in poor state

Explosion on deck

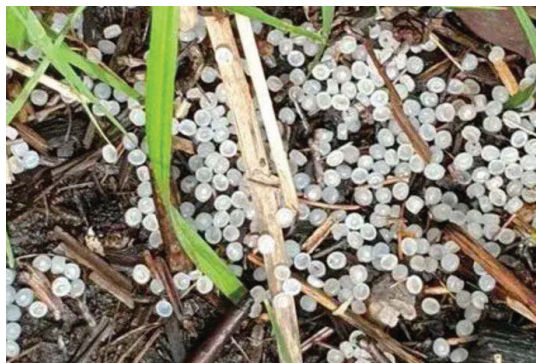
Cargo stows on container, bulk, vehicle and general cargo vessels are particularly vulnerable to more extreme rolling and pitching. Stowage failures can lead to more than cargo damage. They can result in structural damage, fires and may also cause the ship to list, compromising stability and potentially disabling the ship.

Cargo that falls overboard can also endanger other vessels at sea. There is inevitably an

environmental impact from cargo that sinks or ends up washing ashore as debris. Gard has seen clean-up costs in several cases running into many millions of dollars, particularly if plastic nurdles (below, left) are involved.

- It is a good investment to refresh and update the skills of navigators in storm avoidance, weather analysis, and routing strategies.
- lashings may need checking as they may have slackened during the voyage. However, it is important that such checks are done in good time and safe conditions. If a stow failure does occur it may also be unsafe to send the crew into cargo areas to try and re-secure it until better conditions permit.

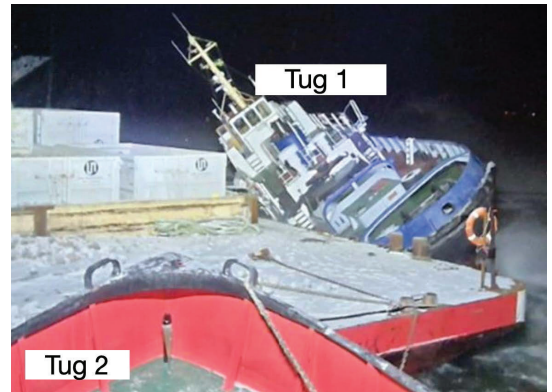
Within seconds tug 1 ran hard aground at a speed of 11 knots. The grounding was violent, and the ship immediately listed heavily to port some 40 degrees. Both the master and the crewmember fell out of the wheelhouse and landed on the port bridge wing. To avoid being exposed to the cold water, the Master released the ship's life raft.

The investigation subsequently found that tug 1's ENC did not meet the standards for an approved electronic chart, and lacked information on the quality of the depth data. Additionally, the ENC's setup made use of the same colour palette for depths between 3m and 10m. Because the tug's draft was 4.2m, this setup gave no colour indication of the shoal danger. Another weakness in tug 1's ENC was that it had no limit on how far it could zoom in. Electronic nautical charts that are over-zoomed can lead a user to believe that the

Tug aground and listing

- In this occurrence, the tug crew's concentration on one task, that of breaking ice and visually following the ice channel, blinded them to the impending danger. They ran aground at full speed.
- Situational awareness is the critical factor for a navigator. It cannot be repeated enough: Use all possible means to determine your position.
- The proper use of ENC's or ECDIS is critical to sharpen your situational awareness and risk appreciation. The correct safety depth and/or colour palette selection can make the difference in grounding your vessel, or not.

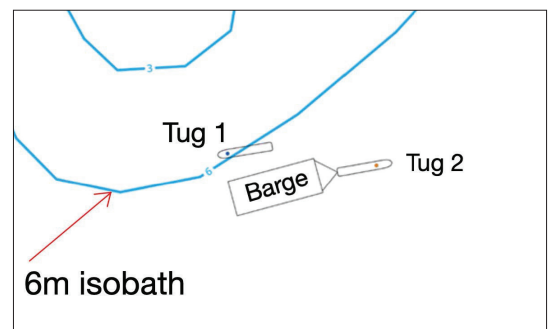
accuracy is increased to the same extent, which is not the case.
