Mariners' Alerting and Reporting Scheme

MARS Report No 359 September 2022

MARS 202237

Hold access fatality/lack of oxygen

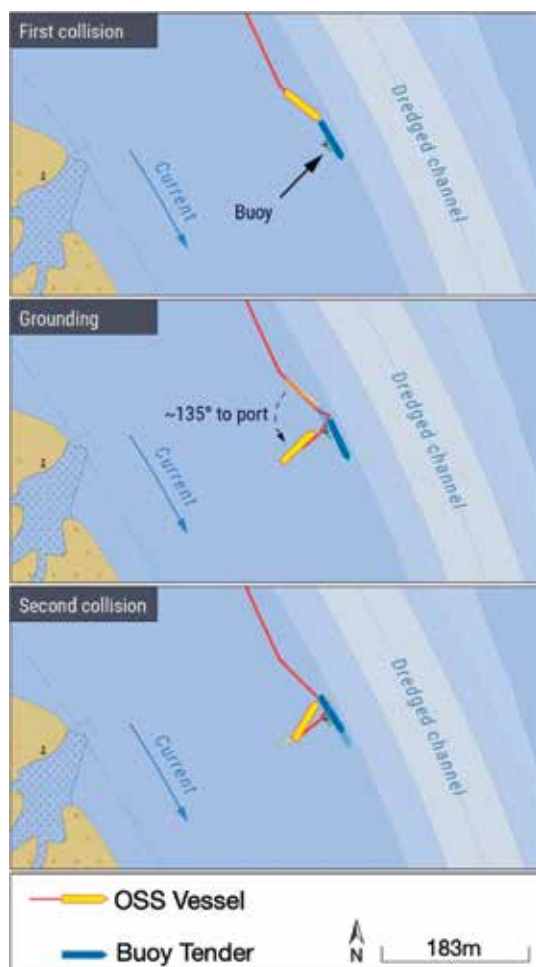
At 1544, the bow of the OSS vessel collided with the stern of the stationary buoy tender while making 6 knots. The OSS vessel then pivoted and slid down the tender's starboard side and grounded on the mud banks to the starboard of the buoy tender. Some 45 minutes later, with the buoy tender still in the same position, the OSS vessel re-floated. The Master of the OSS vessel attempted to manoeuvre around the stern of the buoy tender but the ebb current set it onto the stationary Coast Guard vessel. Recognising that a second collision was imminent, the buoy tender's Master made another ship-wide announcement warning the crew to brace for impact. The offshore supply vessel's starboard bow struck the tender's starboard quarter.

The OSS vessel's Master had assumed that the stationary buoy tender's position was not at the edge of the channel. This led to his decision to pass the buoy tender on its starboard side. Last minute manoeuvres, initially to avoid grounding and then to avoid collision with the buoy tender were unsuccessful. Another factor contributing to the collision was that the buoy tender crew did not question the passing arrangement proposed by the OSS vessel's Master.

The buoy tender remained connected to the heavy buoy anchor on the sea bottom and was therefore unable to manoeuvre and evade the OSS vessel. If the crews had communicated more fully with each other, they might have agreed for the OSS vessel to wait until the buoy tender could move on.

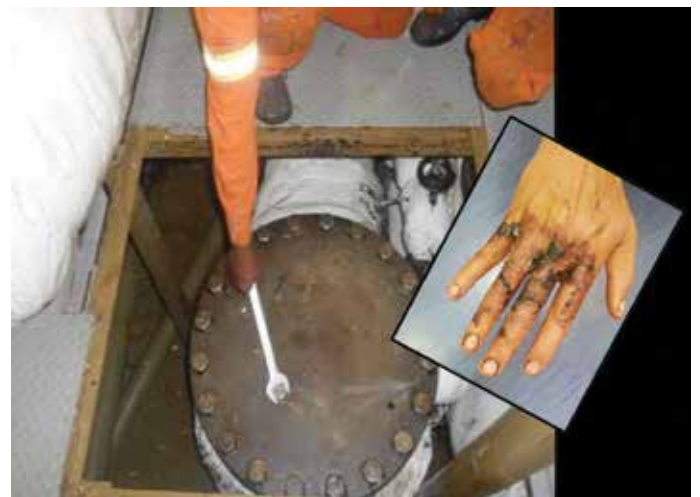
To begin, one crewmember used a spanner to loosen the vent nut on the strainer. As the nut came loose, hot liquid bitumen was ejected from the vent. The bitumen hit the crewman's right hand causing burns; the crewmember was not wearing work gloves. He was immediately brought to the accommodation and given first aid. After consulting the company doctor, he was started on a course of antibiotics as a precautionary measure.

- Wearing proper personal protective equipment (PPE) is a minimum precaution in any work space.
- Over and above wearing proper PPE, risk assessments, even if ever so cursory (what could happen?), should be done to prior to executing a task. In this instance, given the preheating of the bitumen, it would seem common sense to assume that hot bitumen would excrete from the loosened vent nut.
