# Mariners' Alerting and Reporting Scheme

MARS Report No 362 December 2022

## Deadly MOB while rigging pilot combination ladder

### Fatal collapse of portable tween-deck

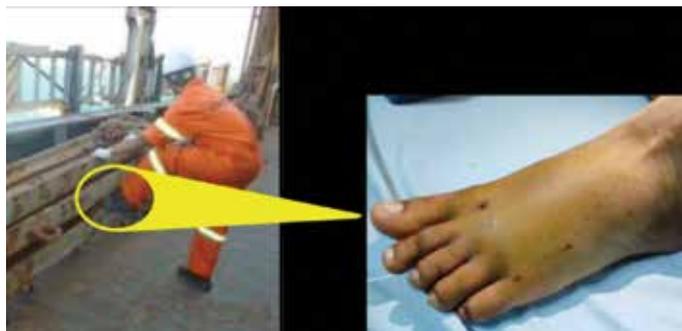
➔ The vessel was preparing to load a cargo of timber. The ship's crew were arranging the stanchions on the ship side that would be used for the timber stow on deck. One upright got stuck and the deck crewman attempted to pull it free, keeping his left foot underneath the upright for leverage. His left foot got stuck between two uprights, resulting in a foot injury. He was taken to the ship's hospital for treatment, put on light duties and recovered completely within two weeks.
