## In this bulletin...

### **MARS 202530**

Three enclosed space fatalities

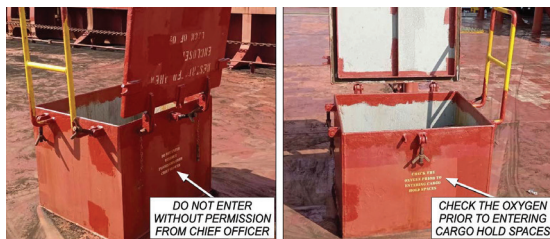
enclosed space awareness training. Post mortem examinations were not conducted, and the cause of death was not confirmed. However, atmospheric readings taken at the forward access space to cargo hold No.8 after the accident show a deficiency of oxygen and a high level of H<sub>2</sub>S. It is highly likely that the noxious air caused the victims to become incapacitated upon entry into the cargo access space, and the resulting accelerated shutdown of their brain and/or lungs led to their death.

**As with many enclosed space entry casualties, warnings on access hatches go unheeded or unseen**

- Effective access control, either by a physical barrier or robust entry procedures that prevent easy access to hold spaces, will reduce enclosed space casualties.
- Enclosed space awareness training for stevedores will enhance safety on vessels.
- A false sense of security is easily set in place. In this instance, there had been many days of loading with less than adequate control over hold access with no apparent consequences. Then disaster struck – a stevedore entered hold 8 which had noxious gases. As rescue operations were mustered, less than adequate ‘accident scene control’ allowed two more fatalities to occur.

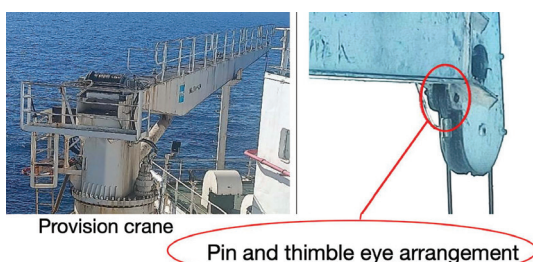
Provision crane

There was no staging rigged at this location. In order to connect the thimble end of the new wire to the securing point at the head of the crane boom, a crew member lay on his stomach over the crane boom and inserted the locking pin through the thimble eye with his outstretched hands. Essentially working by feel alone, the crew member inadvertently and unknowingly put the pin back in place without passing it through the thimble. The thimble remained in place, stuck between the boom structure and the locking pin.

Three days later, the hydraulic ram had been fitted, and the provision crane was load tested. A water bag of the required weight was lifted and swung outboard. As the load came on the wire, the thimble eye of the hoisting wire came out of its stuck position. The crane's block, water bag and dynamometer fell in the water. They were later retrieved by shipyard staff.

Pin and thimble eye arrangement

- After any safety significant work by crew, a senior officer should undertake a close-up inspection of the finished task for quality assurance.
- Proper access to the workspace is a must. Never 'work blind'.
